About this application note

This application note seeks to correct a problem that may occur when using the **In Situ Programming (ISP)** feature on **ST7MDT1-DVP2** and **ST7MDT2-DVP2** development kits.

Workaround to ISP Mode Limitation on the ST7MDT1-DVP2 and ST7MDT2-DVP2

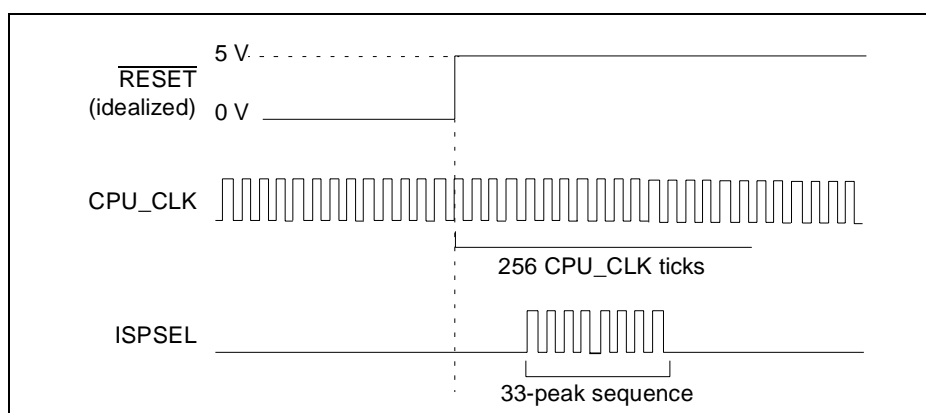
Normally, when there is no capacitance at the $\overline{\text{RESET}}$ pin, ISP mode is initiated by the following sequence, illustrated in *Figure 1*:

Figure 1: "Ideal" signal transmission at ISP mode initiation ($\overline{\text{RESET}}$ pin has no capacitance)

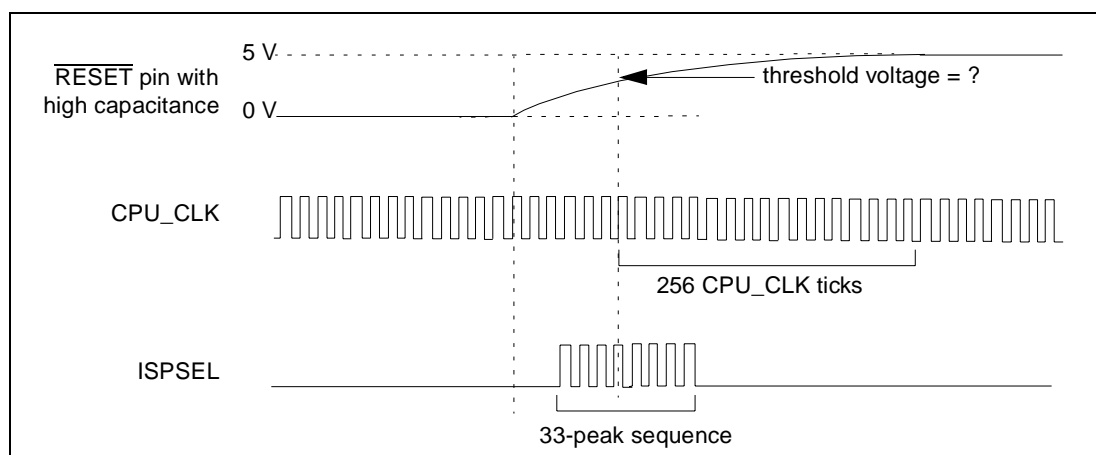
The problem arises when (for various worthy reasons) you have designed your application board with protections that result in a high capacitance at the target MCU's $\overline{\text{RESET}}$ pin. The result is that following a chip reset, the return of the pin to 5 V can be very gradual, rather than instantaneous.

As the voltage gradually rises at the $\overline{\text{RESET}}$ pin, at some unknown threshold voltage (probably in the vicinity of 3.5 V, but this is dependent on several factors), the target MCU begins to count out 256 CPU_CLK timer ticks, during which time the MCU is "listening" for the ISPSEL signal.

However, because the ISPSEL signal sequence is sent from the ISP driver independently of the $\overline{\text{RESET}}$ pin value, in a high capacitance scenario it becomes very likely that the 33-peak ISPSEL signal sequence will begin transmission before the MCU is ready to receive it (i.e. before the voltage on the $\overline{\text{RESET}}$ pin has reached its threshold value). *Figure 2* illustrates this sequence of events.

The result is that the target MCU doesn't receive the ISPSEL signal sequence in its entirety and therefore cannot be put into ISP mode to accept programming.

Figure 2: Signal transmission when $\overline{\text{RESET}}$ pin has high capacitance

The first way to ensure that ISP mode functions correctly is to design your application board so that the RESET pin has low capacitance.

However, we recognize that this isn't always possible, and so have provided a workaround involving the following three steps:

- 1 Updating your version of WINEE (Windows Epromer) to version 4.0.
- 2 Modification to the DVP hardware—linking several pins of the ISP driver chip together by soldering two wires.
- 3 Reprogramming the ISP driver firmware.

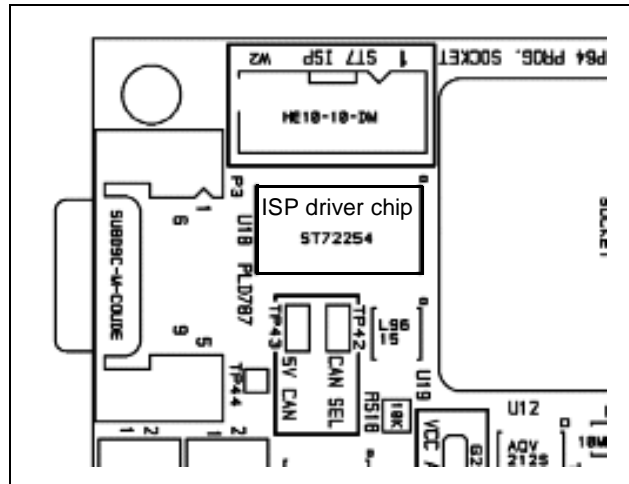
Figure 3: Location of ISP driver chip on the ST7MDT2-DVP2

- 1 Locate the ISP driver chip (ST72254), labelled U18, in the corner of the DVP board, close to the ISP connector. *Figure 3* shows the location of the driver chip for the ST7MDT2-DVP2. The driver chip is in a similar location on the ST7MDT1-DVP2.
